AIRCRAFT GROUND-FLOTATION INVESTIGATION

PART IV. DATA REPORT ON TEST SECTION 3

U. S. ARMY ENGINEER WATERWAYS EXPERIMENT STATION

TECHNICAL REPORT AFFDL-TR-66-43, PART IV

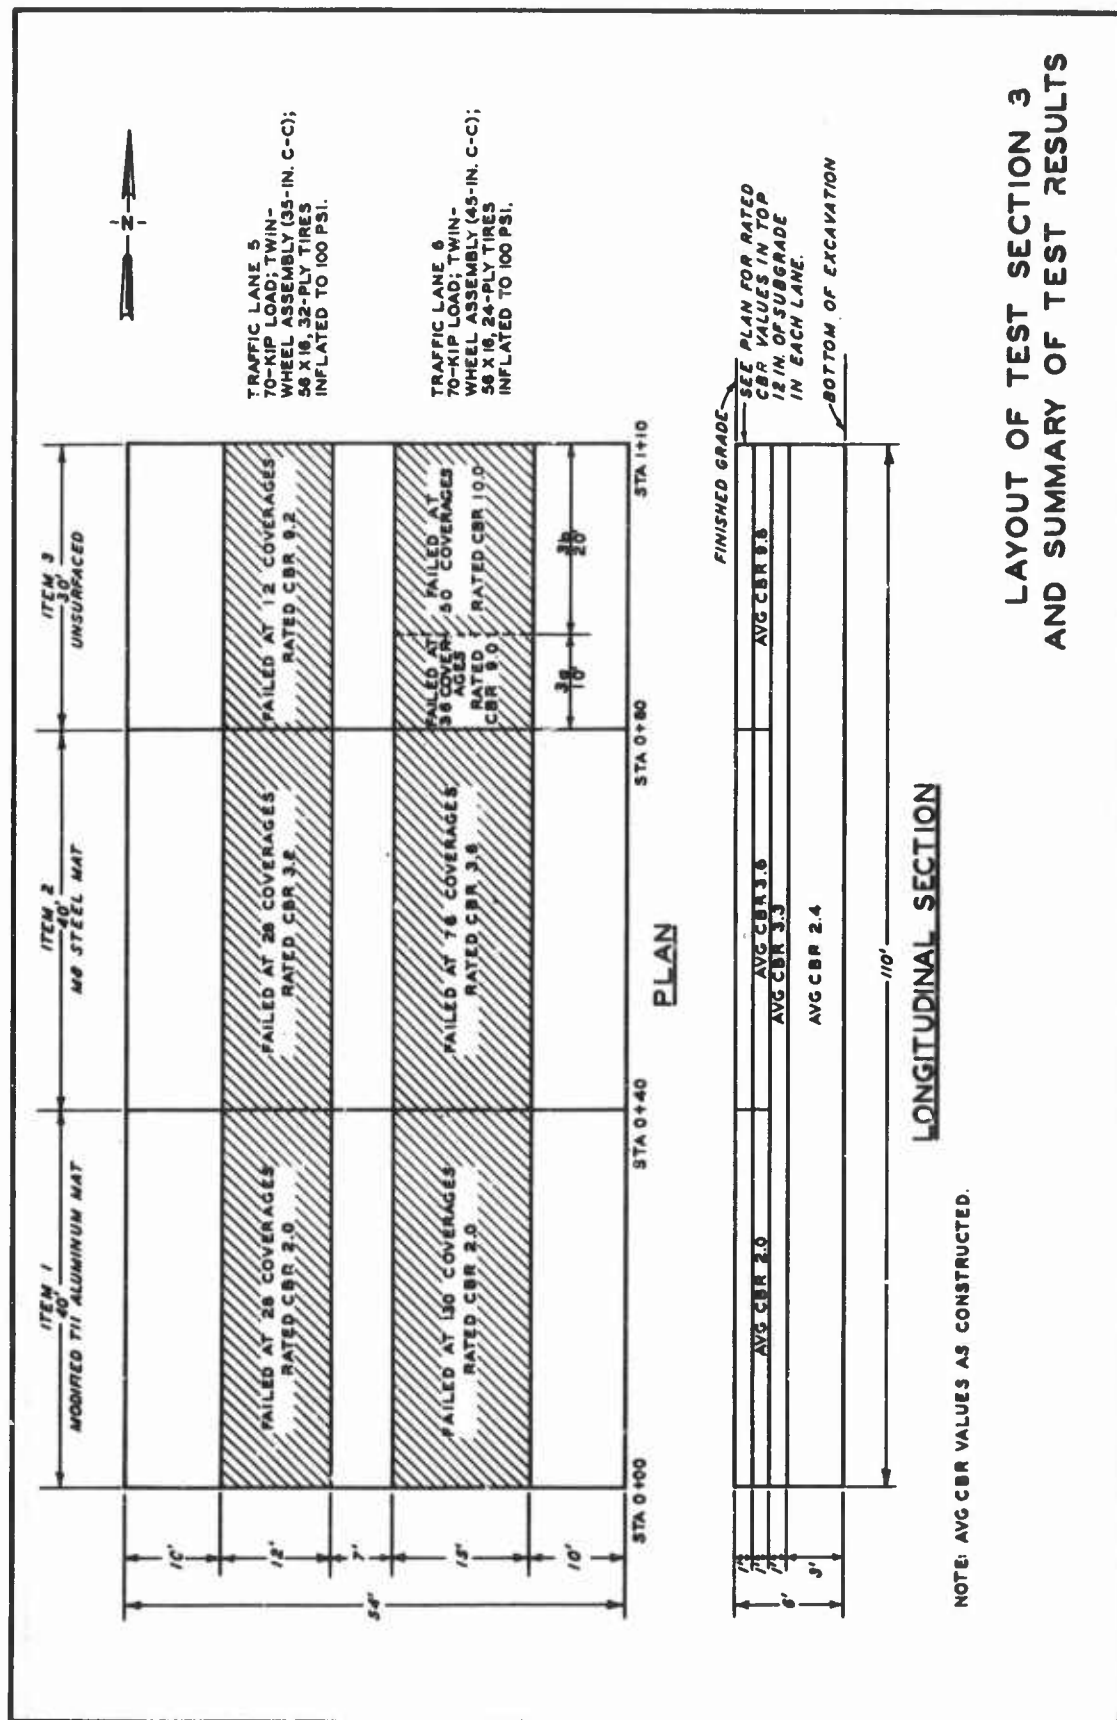
Figure 18

The test section (**Fig 18**) was constructed within a roofed area in order to allow control of the subgrade CBR (California Bearing Ratio) in the test items. Construction of the test section was accomplished by first excavating a 48- by 110-ft area to a depth of 6 ft. The excavated area was backfilled to the original grade level in compacted lifts with a heavy clay soil (buckshot; classified as CH according to the Unified Soil Classification System, MIL-STD-619). Gradation and classification data for the subgrade material are given in Part I.

Two traffic lanes, each divided into three items, were constructed in the test section. Different subgrade strengths were obtained in the items (**Fig 18**) by controlling water content and compaction effort. Items 1 and 2 were surfaced with modified T11 aluminum and M8 steel landing mats, respectively (**Fig 19**). Item 3 remained unsurfaced. The landing mats used are described and illustrated in Part I.

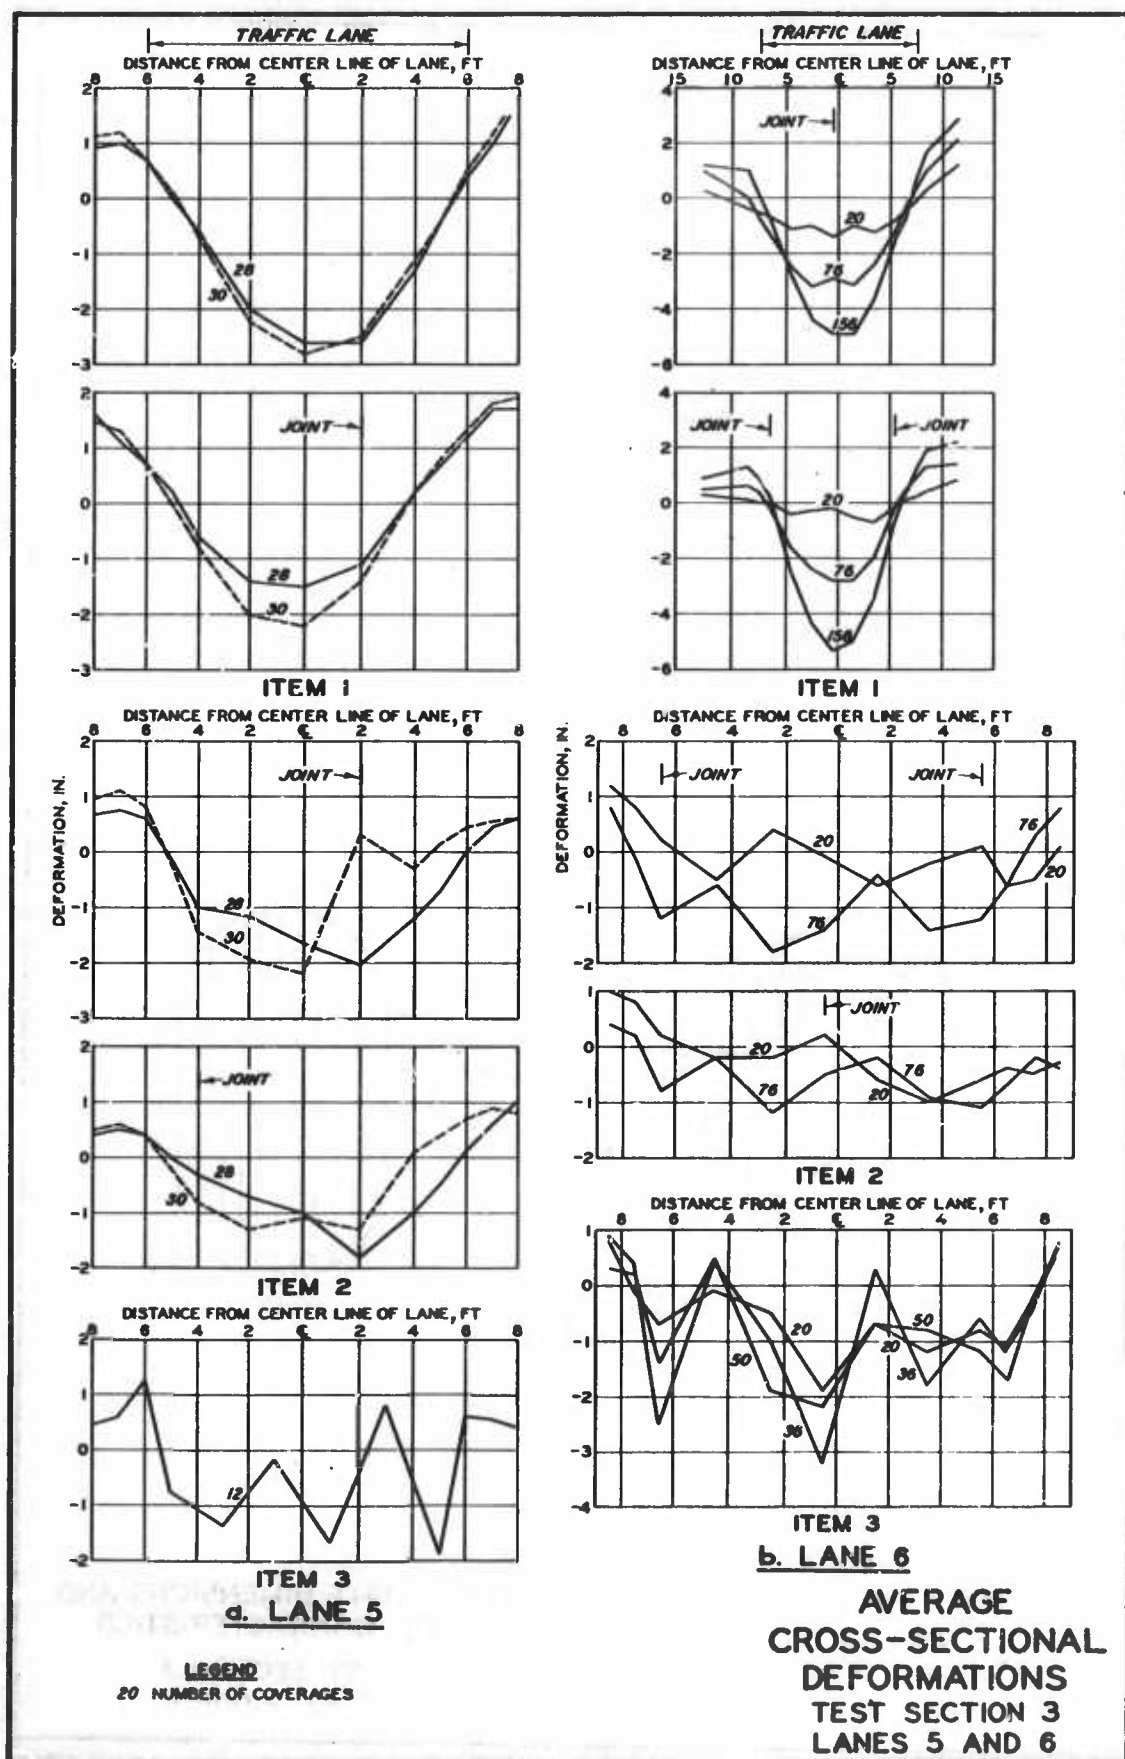
Figure 21
24

- b. Deformation. Average cross-section deformations at 28 and 30 coverages are shown in **Figure 21**. Considerable change in cross section occurred between the two coverage levels, particularly at the mat joint line. Profile deformation along a joint line 4 ft off of the lane center line is shown in **Fig 22**. Maximum dishing of about 0.50 in. was measured at failure.
